DEPARTMENT OF TRANSPORTATION**DIVISION OF ENGINEERING SERVICES**

Contract #: 04-0120F4Cty: SF/ALA Rte: 80 PM: 13.2/13.9File #: 69.28**WELDING INSPECTION REPORT****Resident Engineer:** Pursell, Gary**Address:** 333 Burma Road**City:** Oakland, CA 94607**Report No:** WIR-004076**Date Inspected:** 25-Sep-2008**Project Name:** SAS Superstructure**OSM Arrival Time:** 1400**Prime Contractor:** American Bridge/Fluor Enterprises, a JV**OSM Departure Time:** 2300**Contractor:** Zhenhua Port Machinery Company, Ltd (ZPMC), Changxing Island **Location:** Shanghai China**CWI Name:** Sha Zhi/Wu Ming Kai**CWI Present:** Yes No**Inspected CWI report:** Yes No N/A**Rod Oven in Use:** Yes No N/A**Electrode to specification:** Yes No N/A**Weld Procedures Followed:** Yes No N/A**Qualified Welders:** Yes No N/A**Verified Joint Fit-up:** Yes No N/A**Approved Drawings:** Yes No N/A**Approved WPS:** Yes No N/A**Delayed / Cancelled:** Yes No N/A**Bridge No:** 34-0006**Component:** OBG/ Tower**Summary of Items Observed:****Strut Mock-up Bay 4**

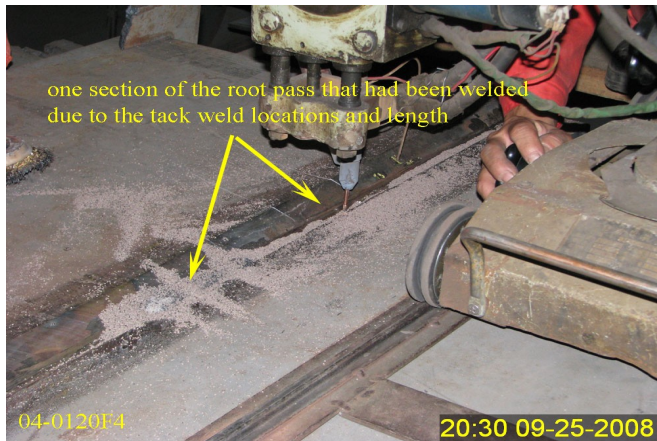
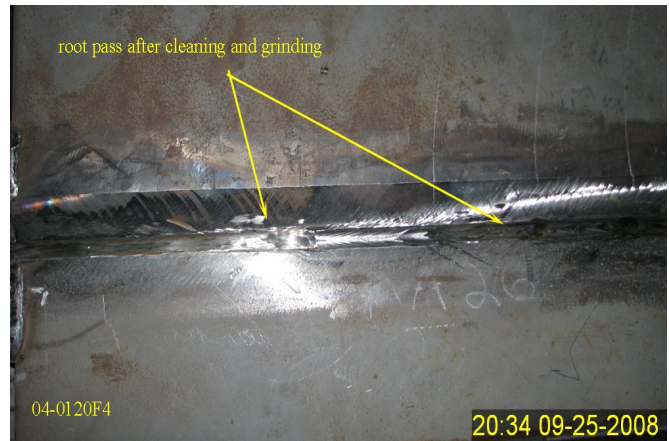
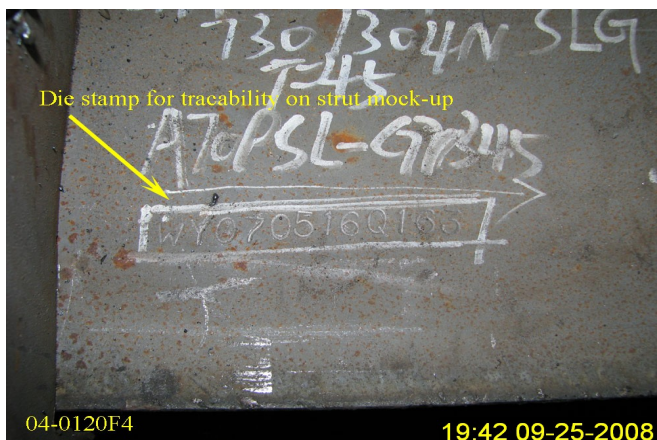
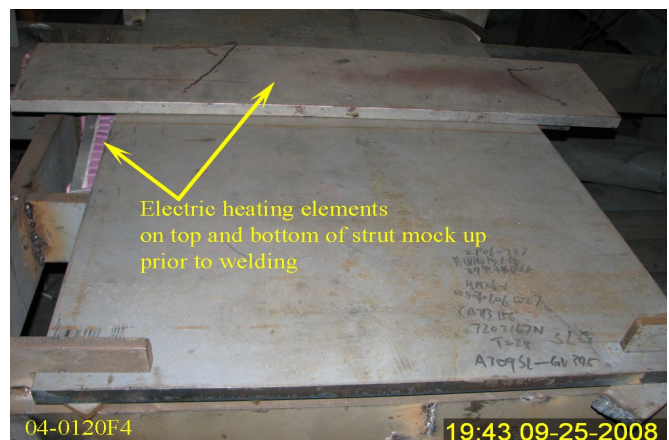
This QA Inspector was observed ZPMC starting the pre-heat for web plate MA26 on the strut mock up. Electric heaters were placed on both side of the web plate to achieve the minimum temperature of 140°C. The actual temperature reached was 164°C prior to welding at the 60mm thick plate. The web plate is a transition CJP weld splice from 28mm to 60mm plate. The root pass was placed with the SAW process in 2 sections due to the tack welds being long in length. Once the root pass was completed ZPMC personnel used a 150mm electric grinder to clean the root pass. ZPMC and ABF personnel examined the area and found it to be acceptable to proceed with the intermediate weld passes. ZPMC placed 3 intermediate weld passes to insure enough weld metal for the back gouge and also for the distortion control. This QA Inspector was informed by ZPMC's CWI's Sha Zhi and Wu Ming Kai that they would turn the plate over and perform the back gouge operations (this will probably take place tomorrow on day shift due to being at the end of the shift today). The welding procedure specification utilized for this procedure was WPS-B-T-4221-B-U3c-S-1 with welding operator for the SAW process being Jiang Jingteng – 046830. Welding parameters were taken during the intermediate passes as Amps - 601, Volts – 28.8, Travel speed – 487 mm/min and a calculated heat input of 2.13 KJ/mm. This QA inspector spoke with CWI Sha Zhi on the importance of following the approved procedure for this mock up along with the distortion control plan to be followed. Noted on the components for the top/bottom and web plates for the strut mock-up was die stamps of the heat numbers in the steel for tractability of the 485 Gr. and 345 Gr. material. At this stage in the welding of the strut mock up it appears to be within the guidelines of the approved procedure.

weld joint beveling, drilling thru holes, press forming, closed rib splice welding, closed rib diaphragm fit-up and FCAW welding of splices, closed rib to deck plate fit-up and tack welding and the PJP welding of closed ribs to deck plates. Deck Plates at the gantry stations were, Gantry-1 DP227-001 tack welded, ZPMC had not performed MT for the tack weld locations at the time of Caltrans QA's observation. DP146-001 had SAW and GMAW completed previously. Gantry 2, DP 335-001 and DP335-002 had been completed and sitting at this station for approximately 72 hours. No welding of deck panels was observed in this bay for swing shift to include the tack welding table which appeared idle.

This Caltrans QA observed ZPMC continuing with the fabrication of various Side, Bottom and Edge Panels designated for the SAS OBG. The general fabrication of said items consist of removing of coating from weld joint areas, cutting, splitting of "W" shape beams for "T" stiffeners, splicing of plates, fitting, tack welding and welding. Various T stiffeners were in the beginning stage of being spliced a total of 14 were observed from fit-up to welding in process. Also noted was side plates SP153 and SP366 was in process of being fit and tack welded together for the WT stiffeners to the flat plate.
